# Manhole Inspection Summary

Manhole # S15AA1004MH

**Location** Address: **3614 COTTAGE AVE**

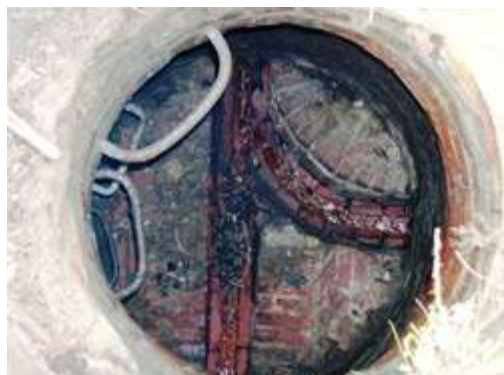
Top View

Corroded steps. Evidence of surcharge - Bench debris. Channel debris.

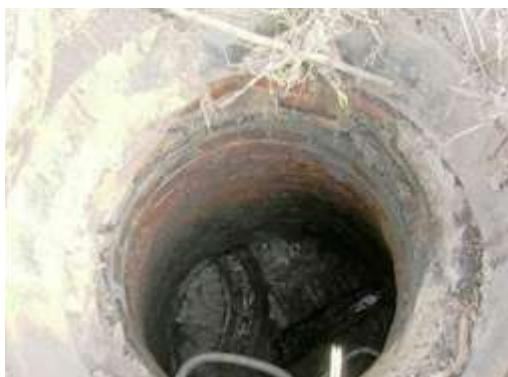
Defect

Frame leaks. Frame offset. Adjustment deterioration, loose brick, root intrusion and infiltration. Corbel and Barrel

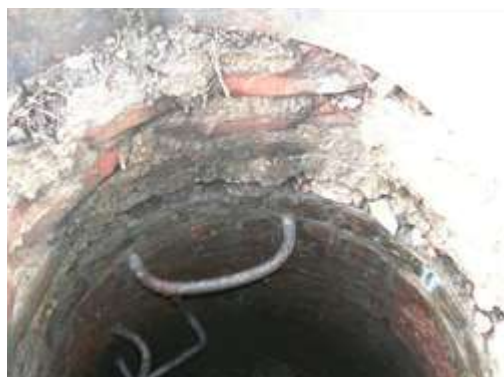
Defect

Frame leaks. Frame offset. Adjustment deterioration, loose brick, root intrusion and infiltration. Corbel and Barrel

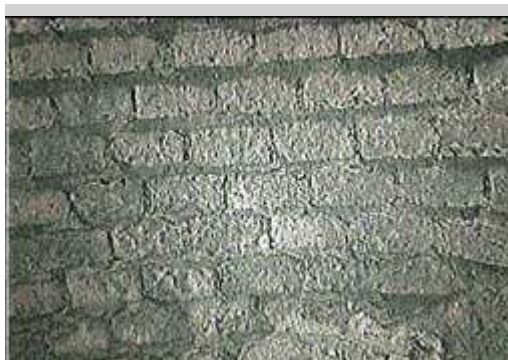
Defect

Barrel deterioration and infiltration.

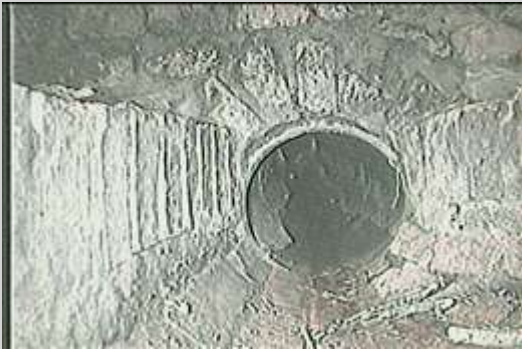
### 8 in. Circular Gravity Sewer Pipe Out @ 12 O'Clock

Deposits: ☐ None ☐ Mud ☐ Sludge ☐ Debris ☒ **Grease**

Infiltration: **Evidence** Pipe Seal Cond: **Unknown**

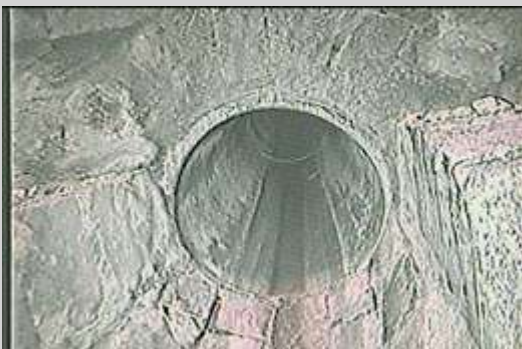
### 8 in. Circular Gravity Sewer Pipe In @ 3 O'Clock

Channel deterioration.

Deposits: ☐ None ☐ Mud ☐ Sludge ☐ Debris ☒ **Grease**

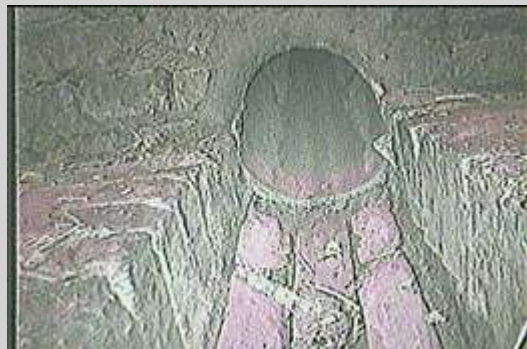
Pipe In @ 6 O'Clock

Deposits: ☐ None ☐ Mud ☐ Sludge ☐ Debris ☒ **Grease**
